# Manhole Inspection Summary

Manhole # S05SS1023MH

Insp Date: **9/25/06 11:27 AM**

**Location** Address: **5443 PARK HEIGHTS AVE**

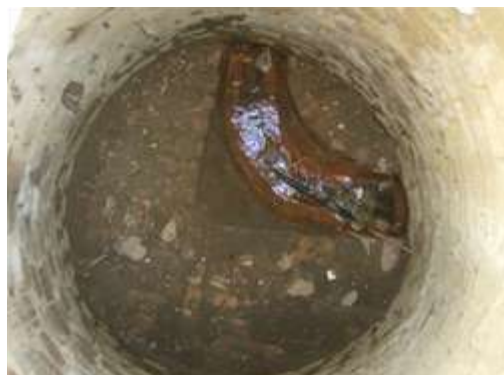
Top View

Infiltration: ☐ None ☒ **Joint** ☐ Cracks ☐ Mortar ☐ Roots ☒ **Wall**

Infiltration: ☐ None ☐ Joint ☐ Cracks ☐ Mortar ☐ Roots ☒ **Wall**

Count: **3** Missing: **3** ☒ **Corroded**

☒ **Evidence Of Surcharge** Depth: **1** (ft.) ☐ Active Surcharge Present

Adjustment and Barrel infiltration.  
Corroded and missing steps. Evidence of  
surcharge - Bench debris.

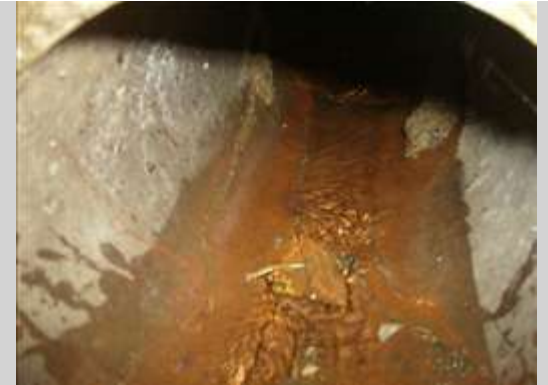
### 8 in. Circular Gravity Sewer Pipe Out @ 12 O'Clock

Condition: ☐ Sound ☒ **Cracked** ☐ Root Intrusion ☒ **Deteriorated** ☐ Leaks ☐ Debris

Channel cracks and deterioration.
